Hill Air Force Base, Utah

**Phase I Environmental Baseline Survey:
Building 260,
Hill Air Force Base, Utah**

December 28, 2009

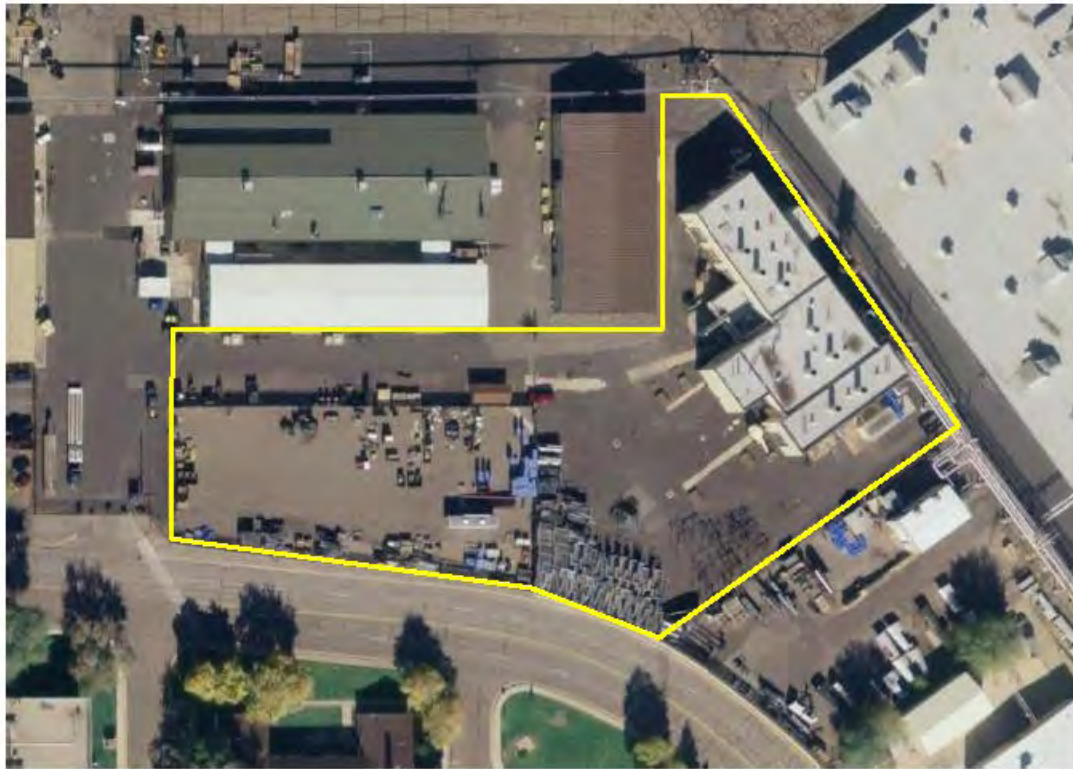
Figure 3: Perimeter of the Subject Property

The site and adjoining properties were visually inspected on November 10, 2009. A map of the subject property is included as Figure 3 of Appendix B. Selected site photographs are included in Appendix C of this report.

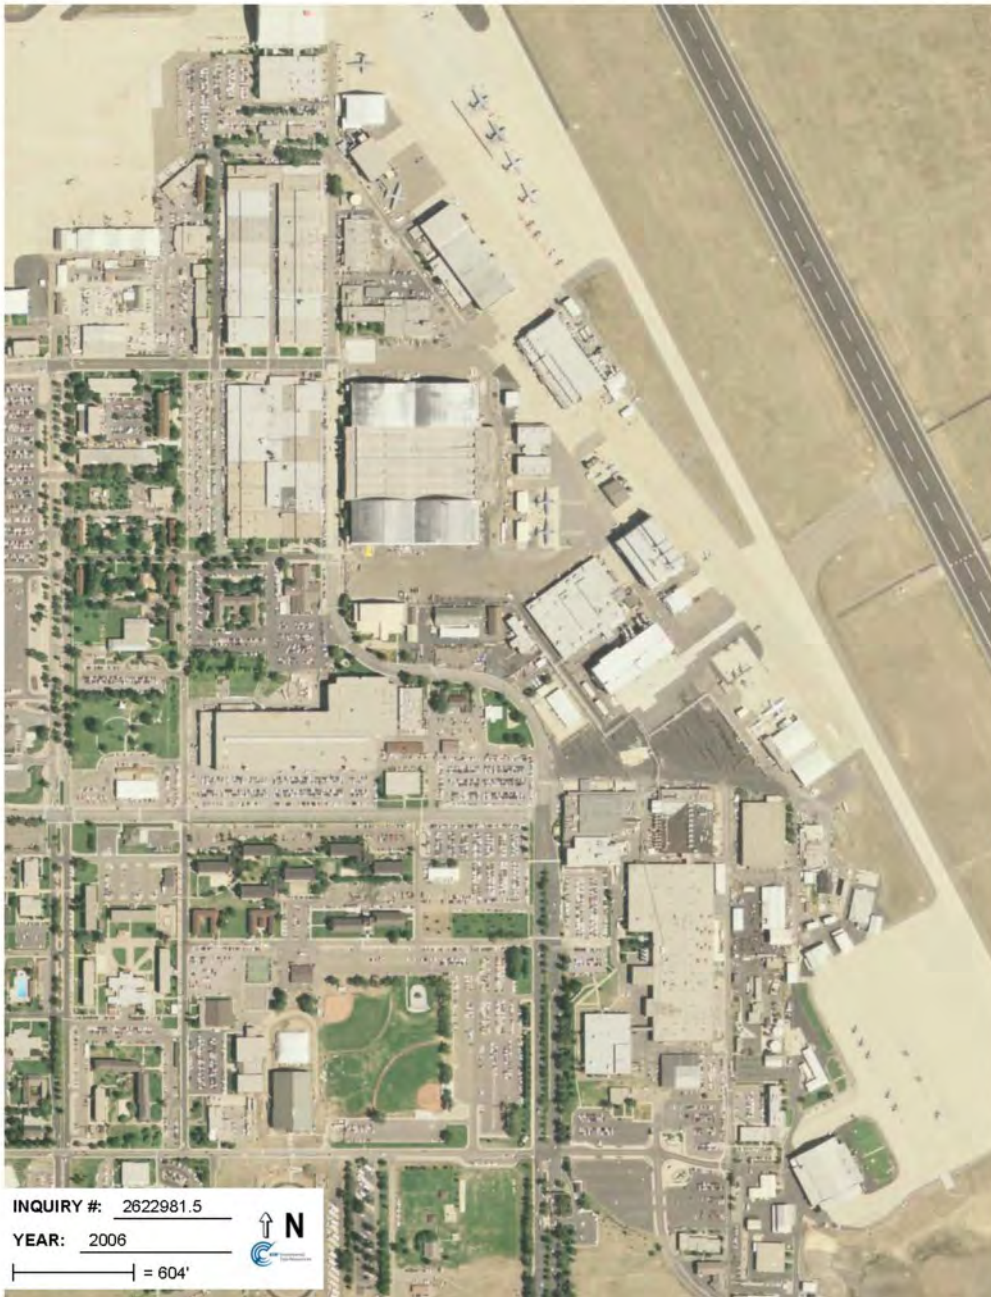
YEAR: 2006

Most of the aerial photographs reviewed were of such poor quality that a determination could not be made regarding condition of the subject property. The best aerial photograph that could be located was dated 2006 (Appendix C). It shows Building 260 in its current configuration.

The best aerial photograph that could be located (2006) is shown on the following page.

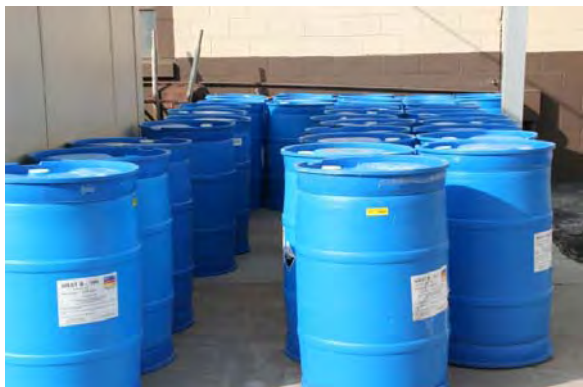
Outdoor storage, empty drums

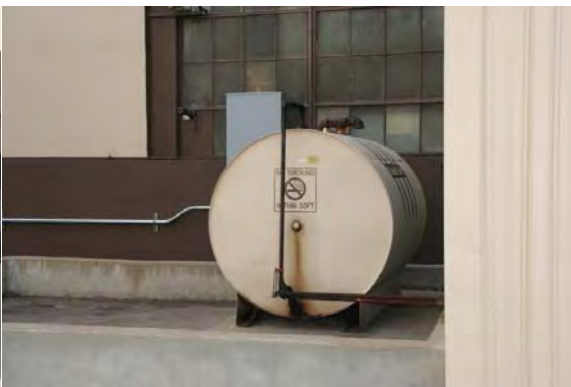
One above ground storage tank (AST) with a capacity of 500 gallons of diesel fuel was observed during the site visit. This AST is positioned over a concrete secondary containment structure.

500 gallon diesel storage tank

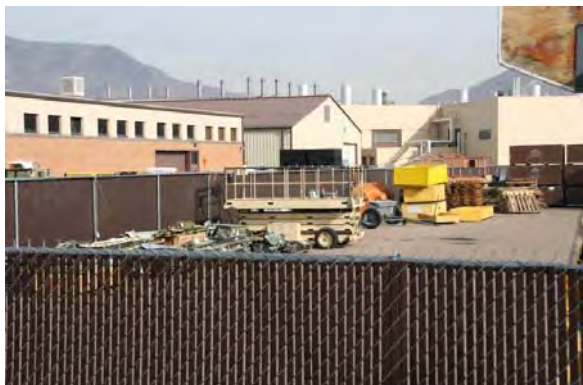
Mr. Brad Robb explained the contents of the storage areas include: vehicles, both functional and surplus; aircraft parts; and other surplus items. The storage areas are paved. Any drips or leaks from the vehicles would be identified, stopped, and the liquids would be removed. No other hazardous materials or waste would be expected to be present.

Fenced storage area

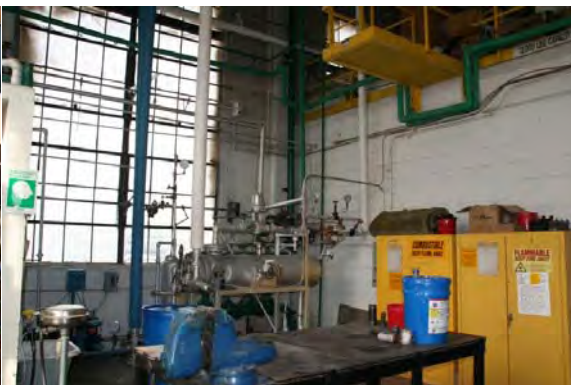
Combustible and flammable storage lockers

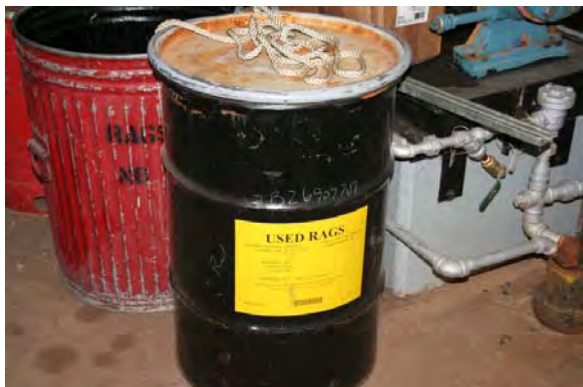
- three cans are present for holding used rags, which are collected and laundered on Hill AFB;
- approximately two gallons per year of used oil is generated and is sent for recycling; and
- when preventive maintenance and repairs are performed on equipment, including the emergency generator, all waste is removed from the building by the maintenance crews for recycling, treatment, or disposal.

Used rags

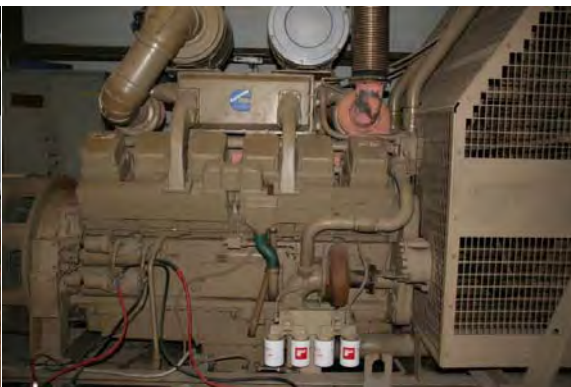
Emergency generator

When preventive maintenance and repairs are performed on the
emergency generator, all waste is removed from the building by the
maintenance crews for recycling, treatment, or disposal.
